1
Name Of Dam: 2 FALLING CREEK FILTRATION PLANT

PHASE I INSPECTION REPORT

6 NATIONAL DAM SAFETY PROGRAM

PREPARED BY
NORFOLK DISTRICT CORPS OF ENGINEERS
803 FRONT STREET
NORFOLK, VIRGINIA 23510

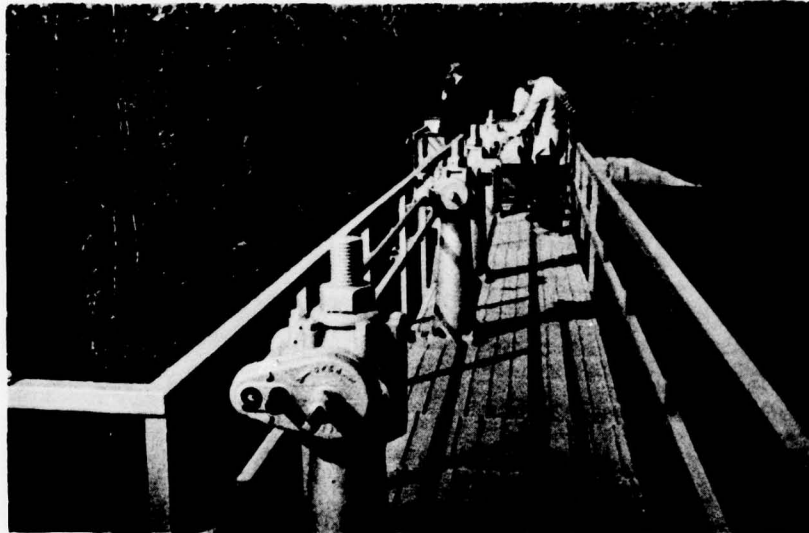
STEEL GATE LIFT ASSEMBLY

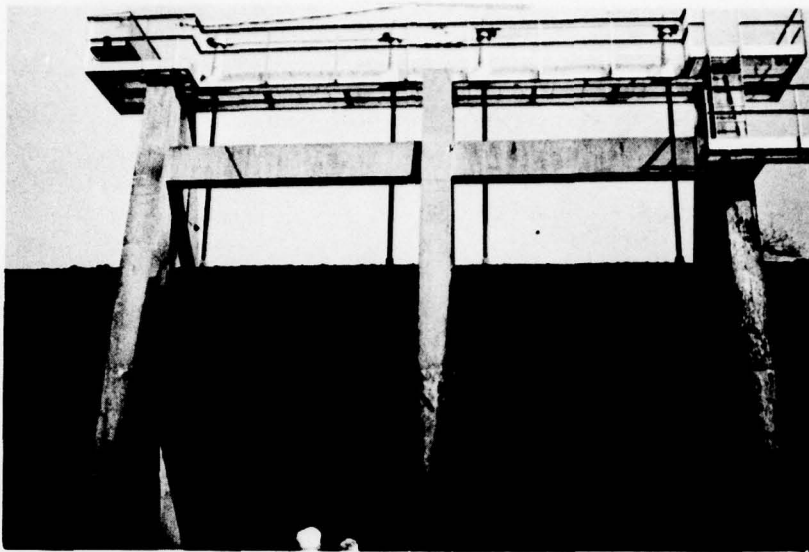
STEEL GATES AND LIFT ASSEMBLY

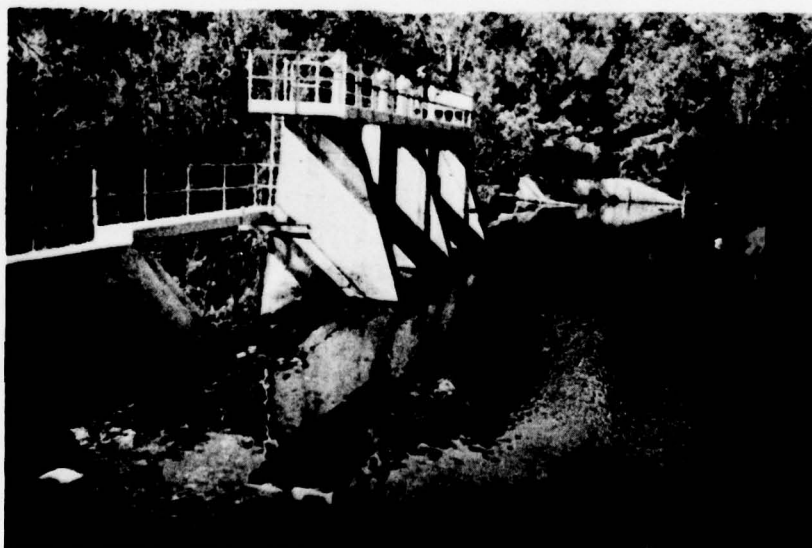
UPSTREAM VIEW OF LIFT ASSEMBLY

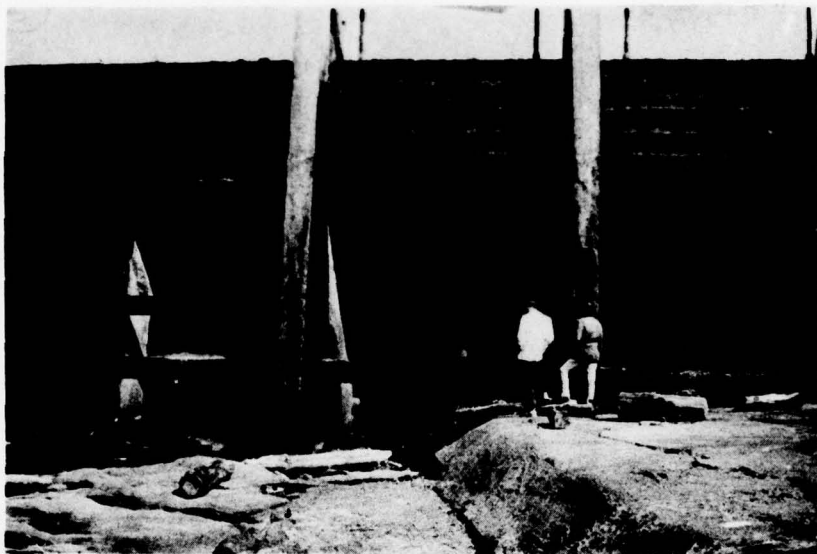
14 INCH WATER SUPPLY PIPE AND CONCRETE APRON
